DEPARTMENT OF TRANSPORTATION

Quality Assurance and Source Inspection

Contract #: 04-0120F4Cty: SF/ALA Rte: 80 PM: 13.2/13.9File #: 1.28**WELDING INSPECTION REPORT****Resident Engineer:**Pursell, Gary**Address:** 333 Burma Road**City:** Oakland, CA 94607**Report No:** WIR-015566**Date Inspected:** 12-Jul-2010**Project Name:** SAS Superstructure**OSM Arrival Time:** 1100**Prime Contractor:** American Bridge/Fluor Enterprises, a JV**OSM Departure Time:** 1930**Contractor:** American Bridge/Fluor Enterprises, a JV**Location:** Job Site**CWI Name:** See Below**CWI Present:** Yes No**Inspected CWI report:** Yes No N/A**Rod Oven in Use:** Yes No N/A**Electrode to specification:** Yes No N/A**Weld Procedures Followed:** Yes No N/A**Qualified Welders:** Yes No N/A**Verified Joint Fit-up:** Yes No N/A**Approved Drawings:** Yes No N/A**Approved WPS:** Yes No N/A**Delayed / Cancelled:** Yes No N/A**Bridge No:** 34-0006**Component:** Orthotropic Box Girders**Summary of Items Observed:**

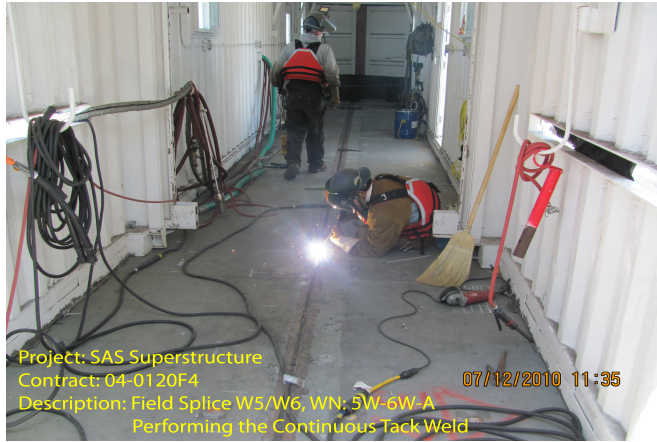
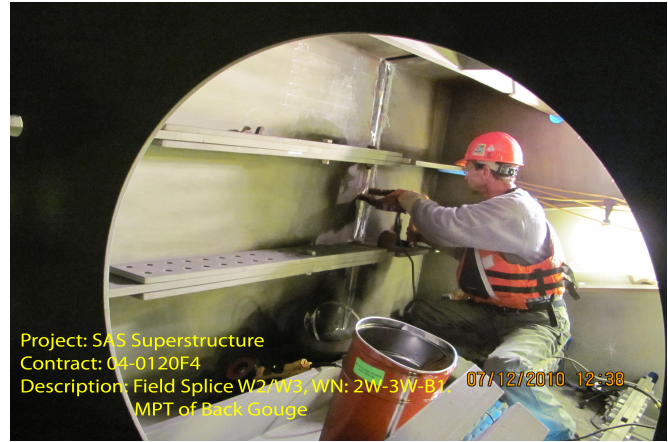
The QAI observed the machining of the back gouged surface on the "B" face of the Complete Joint Penetration (CJP) groove identified as WN: 2W-3W-B1. The machining of the surface was performed by Hua Qiang Hwang ID-2930 to remove slag and carbon residue. The machining was performed utilizing a high cycle 4" grinder. At the conclusion of the initial machining the QAI observed the QC technician Tom Pasqualone perform a Magnetic Particle Test (MPT) and three linear indications were noted by the QC technician which will require additional grinding. The profile grinding was not completed during this shift.

The QAI observed the welder James Zhen ID-6001 perform the continuous tack welding of the deck plate to the backing bar connection of the weld joint identified as WN: 5W-6W-A2 and A3. The welding was performed utilizing the Shielded Metal Arc Welding (SMAW) process as per the Welding Procedure Specification (WPS) identified as ABF-WPS-D15-1200A, Rev. 1. The WPS was also used by the QC inspector, Steve McConnell, to monitor the in process welding and verify the welding parameters. The amperage was verified and recorded by the QC inspector as 135 amps. The QC inspector also verified the minimum preheat temperature of 60 degrees Celsius and a maximum interpass temperature of 230 degrees Celsius. The welding was performed in the horizontal (2F) position with the work positioned in an approximately horizontal plane and the weld metal deposited on the upper side horizontal surface and against the vertical surface. The QAI also monitored the planar alignment of the deck plate at random intervals.

The QAI also The QAI observed the Flux Cored Arc Welding (FCAW-G) of the bottom plate field splice identified as Weld Number (WN): 5W-6W-D, Segment D2. The Complete Joint Penetration (CJP) groove welding was performed by welding personnel Xiao Jian Wan ID-9677 utilizing the Welding Procedure Specification (WPS) ABF-WPS-D15-3040A-1 Rev. 0. The WPS was also used as a reference by the AB/F Quality Control (QC) Inspector Bonifacio Daquinag, Jr. during QC verification of the Direct Current Electrode Positive (DCEP) welding parameters during the CJP welding. The groove joint appeared to comply with the AWS joint designation identified as B-U2a-GF. The QAI also observed the QC inspector verify the average welding parameters and were observed as follows: 233 amps, 22.8 volts and a travel speed measured at 356mm/minute. The QC inspector also monitored the surface temperatures during the field welding and the following was observed and noted by the QAI: the minimum preheat temperature of 60 degrees Celsius and the maximum interpass temperature of 230 degrees Celsius.

The digital photographs on page 3 of this report illustrate the work observed during this scheduled shift.
